## **Rivers Exe and Haddeo, Dulverton, Somerset**

**An Advisory Visit by the Wild Trout Trust, June 2014**

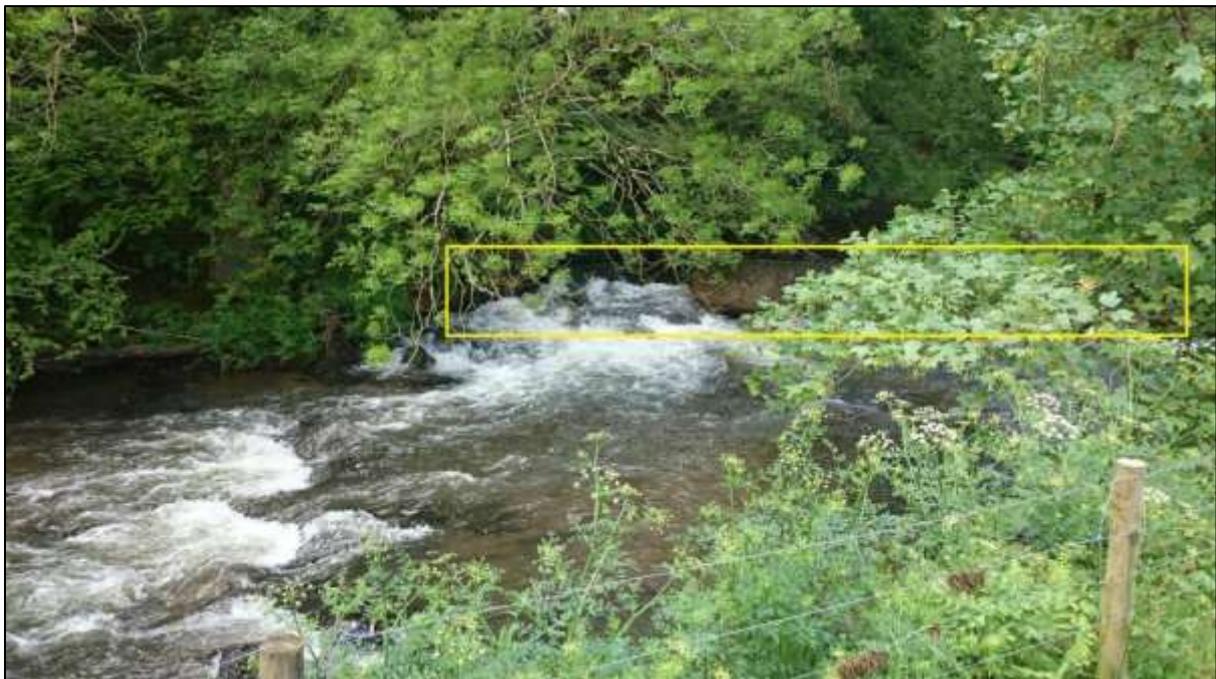
An impounding weir forms the upstream boundary of the fishery just downstream of the bridge crossing on the B3222 (Jury Hill). This weir will impact on fish migration under a wide range of flow conditions. The original function of 'Helebridge Weir' as it is marked on pre-WWII maps is unclear but the structure may have been constructed to divert water through a nearby mill or water meadow system. In either case the structure does not appear to perform any useful function and the river would benefit from its removal.

Figure 2: Helebridge Weir (highlighted by yellow box)

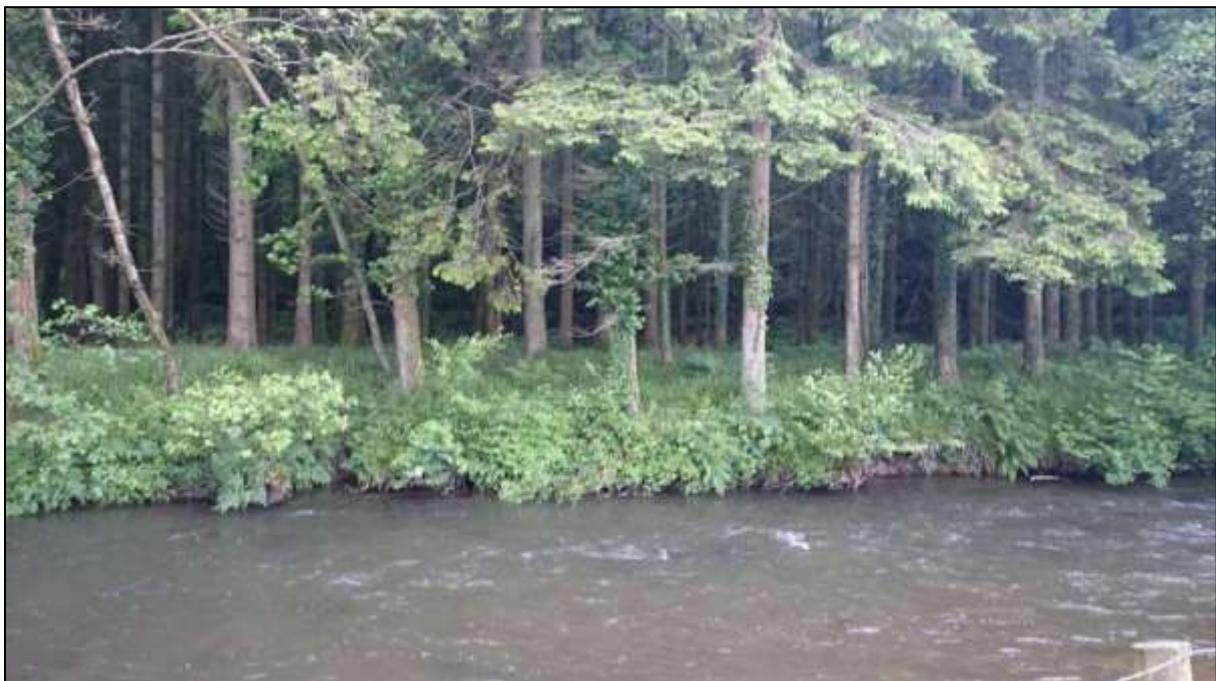
spate flows). This will further limit plant diversity. A rich and diverse marginal and riparian habitat can be important in supporting a healthy upland river ecosystem. The greater the abundance and diversity of bankside plant species, the greater the abundance and diversity of habitat for terrestrial invertebrates and adult river flies. In upland rivers where strong spate flows often inhibit the establishment of aquatic plants such as water crowfoot (*Ranunculus spp.*), terrestrial invertebrates that accidentally drop into the river provide an important dietary supplement for fish. For hatching riverflies, emergent and marginal plants provide a good interface between the aquatic and terrestrial habitats. For mayfly (*Ephemera danica*), marginal and bankside grasses and shrubs provide a resting spot to hatch from subimago (dun) to imago (spinner).

Figure 3: The RB is densely wooded and consists of a mono-culture of conifers in places. This limits bankside biodiversity

2. Engage with the land owner on the Right Bank to explore options to introduce a greater diversity of light conditions by implementing a 5-10 year rotation of tree works. Tree limbs and brushwood arising from these works could be used for bank protection or habitat enhancement structures.

Ideally, a wide buffer of deciduous woodland should be instated between the river and the conifer woodland. Guidance on forestry management in relation to rivers is offered by the Forestry Commission.

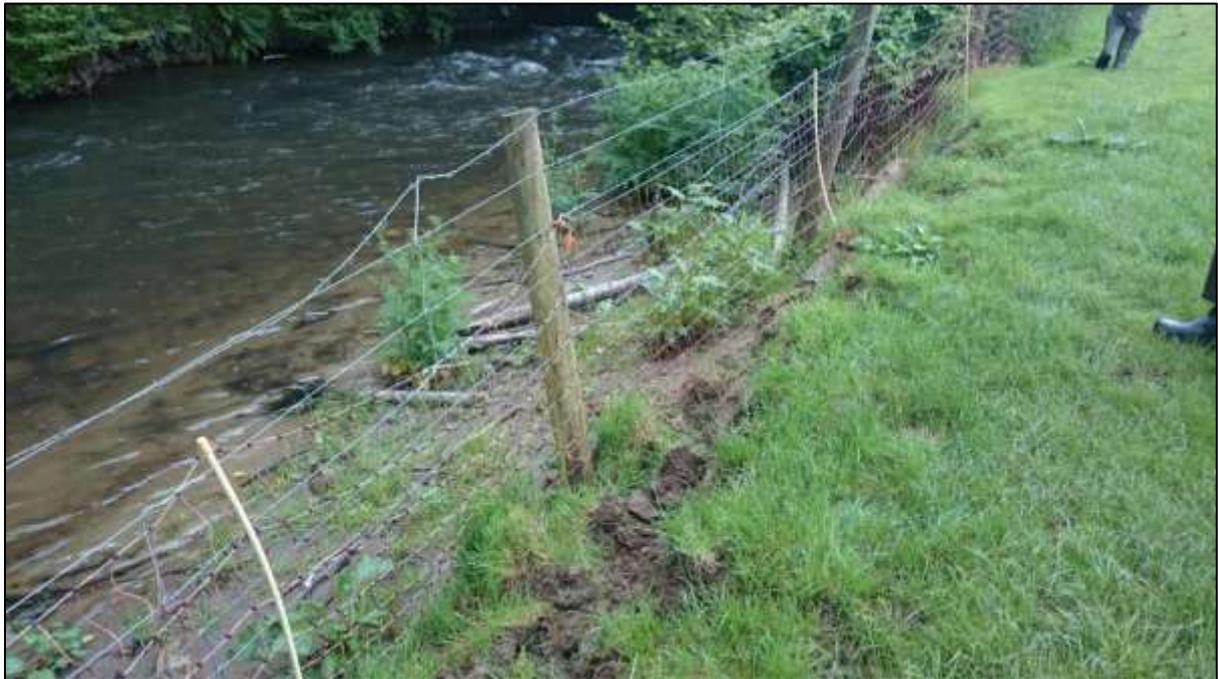
The LB consists of grazed pasture. The bank is stock-fenced to prevent livestock from accessing the river but unfortunately the fence line has been positioned very close to the river. This has allowed grazing right up to the top of the bank which both weakens the bank (by reducing the density of root structure), leading to increased erosion, and compacts the soil, increasing the rate of surface water run-off and potentially adding to the volume of diffuse fine sediment entering the river.

Fencing so close to the riverbank on high-energy systems such as the Exe can be expensive for the land owner /tenant farmer as bank erosion often causes the fence to collapse into the river.

Figure 4: The fence line on the LB is situated very close to the river

1. Engage with land owners/tenant farmers on the Left Bank and explore options to improve land management regarding the river. Ideally, the bank should be stock-fenced at least 3 metres back from the top of the bank, perhaps with gated access so that cattle can graze the buffer once or twice a year to manage bankside vegetation and retain biodiversity. Moving the fence line back from the river will also reduce the risk of the fence collapsing into the river and reduce the associated wasted expenditure on replacement fencing.

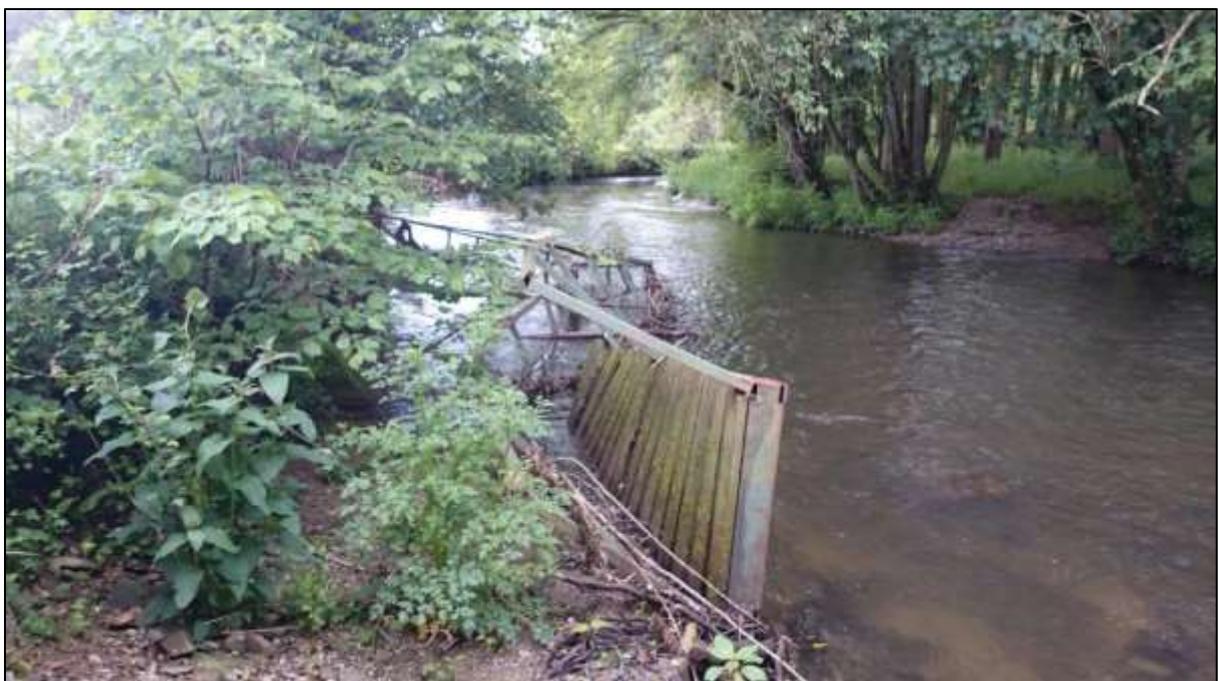
At SS 93426 27323 the mangled remains of a steel footbridge wrecked by winter flows were observed. The power of the river at bank-full flow is an important consideration in the planning of future habitat enhancements.

Figure 5: Powerful spate flows have destroyed a steel footbridge

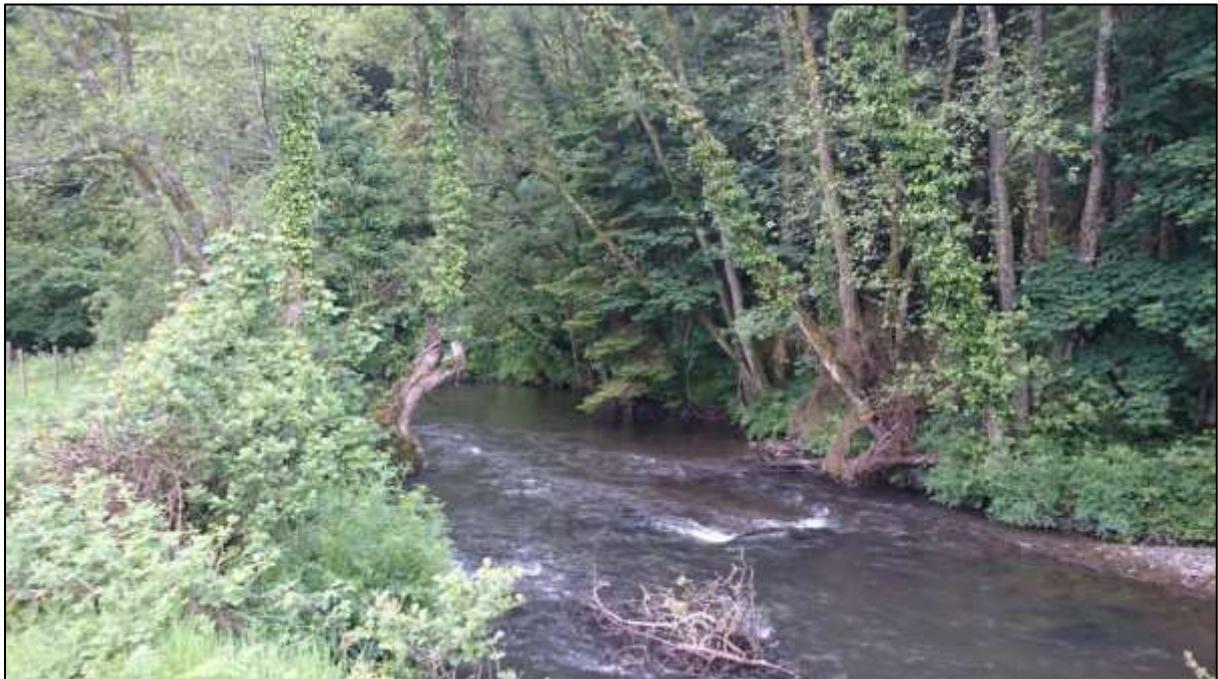
Continuing downstream, a number of bankside trees were observed leaning at precarious angles. In upland rivers, tall bankside trees often topple into the river. This helps to drive the morphology of the river as flow is forced around the tree and scours the bed and bank. Fallen trees also provide important cover and refuge habitat for fish as well as a food source for a range of freshwater invertebrates. However, these are normally only temporary features as the tree is either carried downstream by strong currents or removed by land owners or the Environment Agency for flood defence purposes.

Trees that are likely to soon topple into the river may provide an opportunity to create more permanent habitat enhancement features. These opportunities are discussed further in the *Recommendations* section.

Figure 6: Leaning bankside trees may provide opportunities for habitat enhancement

3. Capitalise on the abundance of bankside trees and introduce further flow diversity and cover habitat by hinging bankside trees into the river downstream and fixing them to the river bed by drilling a one or two holes through the trunk and driving a steel reinforcing bar (rebar) through the hole and into the bed.

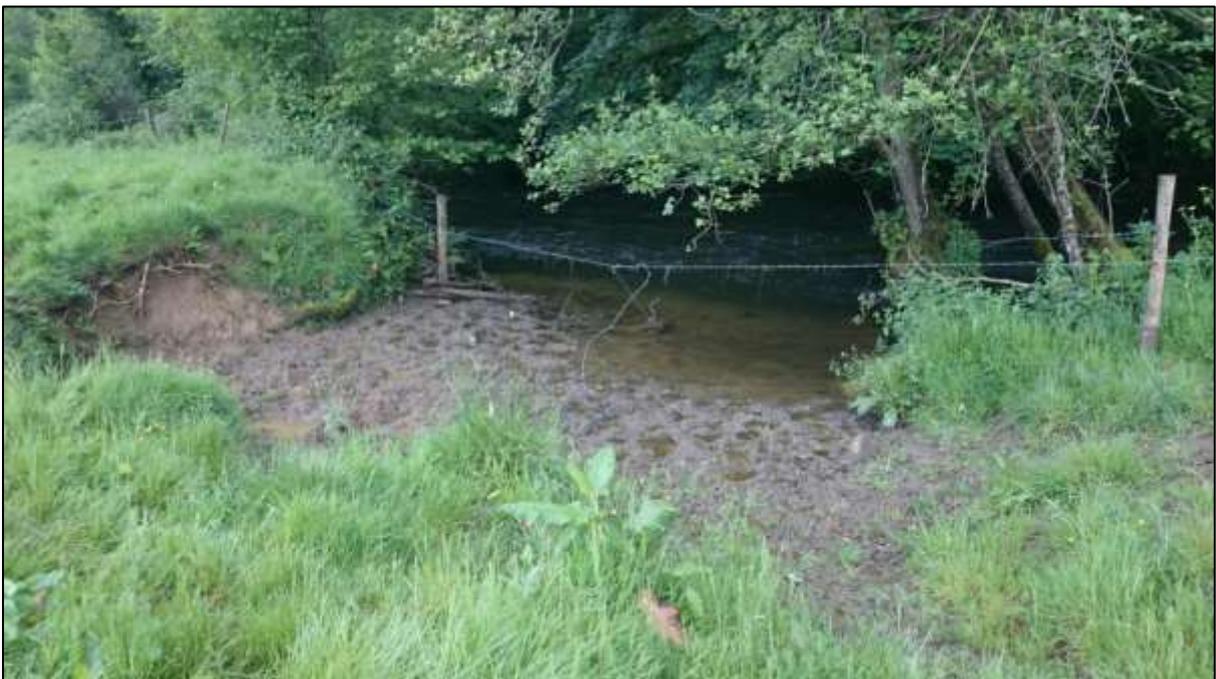
At SS 93494 26895 an informal cattle drink is a point source of fine sediment. Formalising the drink with better fencing and laying down a crushed limestone hard standing would reduce the volume of fine sediment entering the river at this point. An example of good practice cattle drink design is given in the *Recommendations* section.

Figure 8: An informal cattle drink is a point source of fine sediment into the river

4. The cattle drink at SS 93494 26895 could be improved by the introduction of a hard standing and more formalised fencing. This would reduce the amount of bank poaching and the area of bare soil within the drink. This

would therefore reduce the volume of fine sediment washing into the river at this location.

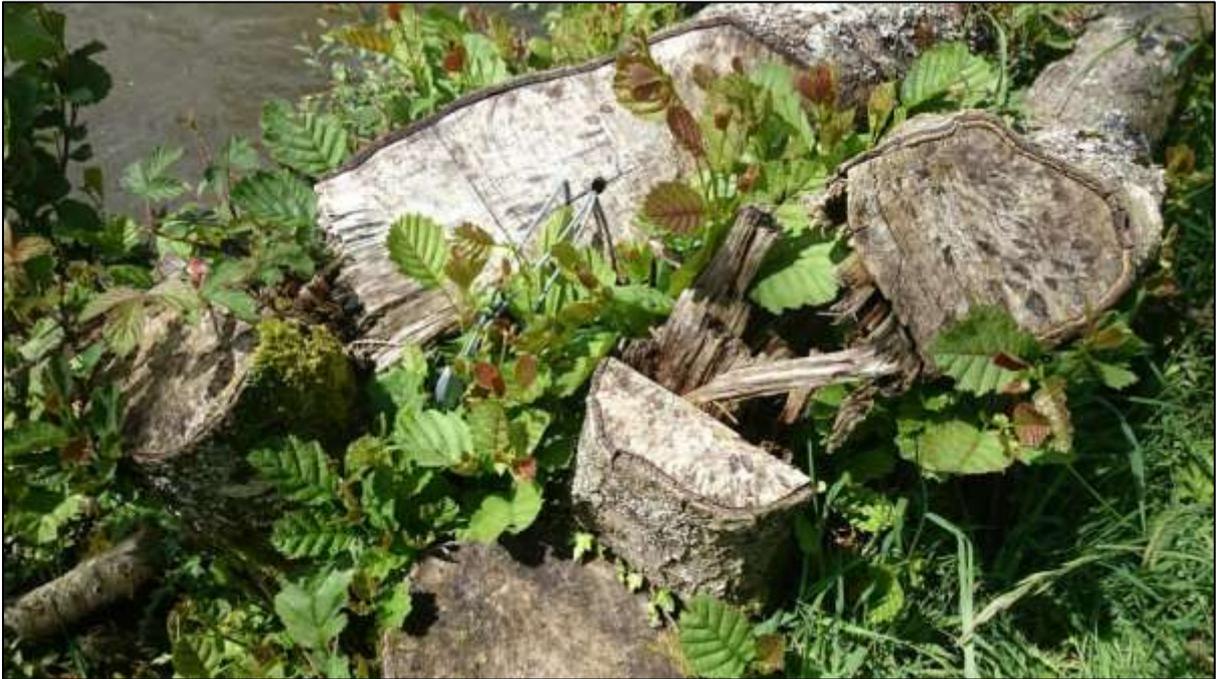
A short section of the Perry beat was visited downstream of Perry New Road. The DAA has undertaken extensive bank protection works in this reach which are now well established and working well. Hinged and cabled bankside trees are combined with faggot bundles of brushwood secured against the bank (Figure 9) and saplings growing up through the bundles will help ensure that the bank protection gets stronger with time (Figure 10).

Figure 9: Hinged trees are also cabled to their original stump for extra security.

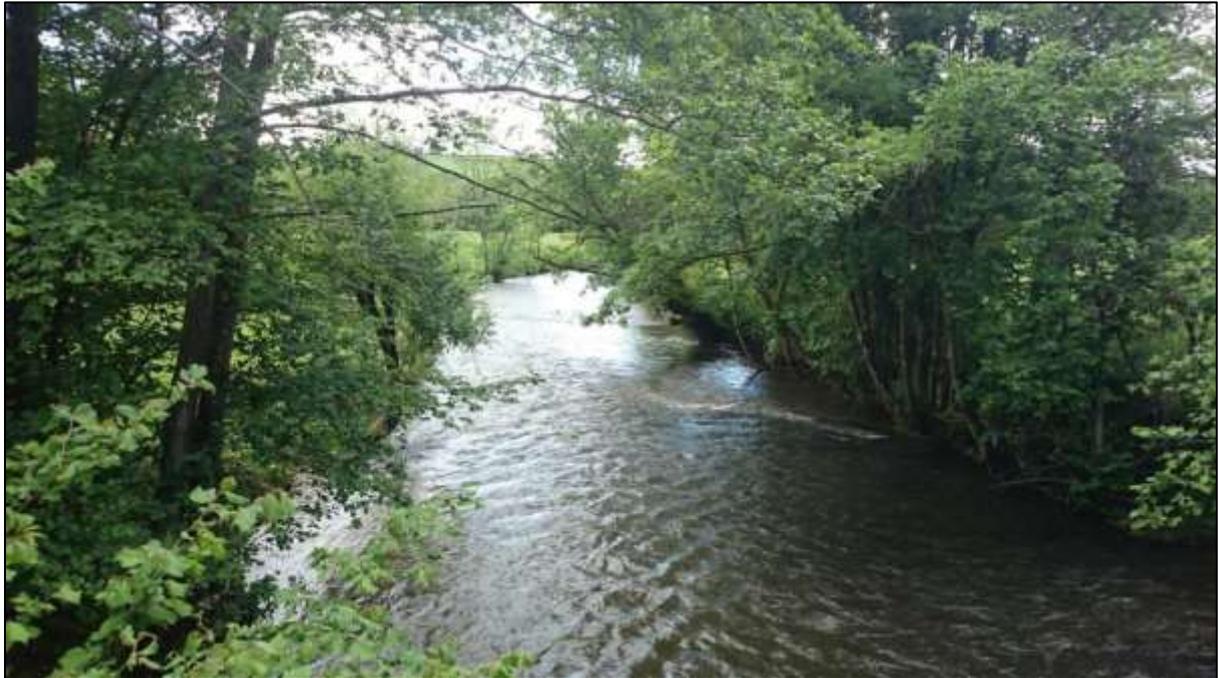
The Perry beat has some good habitat features but is comparatively uniform in width (Figure 11). There is scope to further enhance the Perry beat by the creation of one or two cabled 'kickers' to introduce some flow diversity as well as functioning as trout lies. These structures are explained further in the *Recommendations* section.

Figure 11: The Perry beat provides some good habitat but could perhaps benefit from additional diversity of width and flow conditions

1. Identify and capitalise on opportunities to introduce some additional flow diversity by creating one or two small kickers. Ensure that the cable length is long enough to allow some movement so that the kicker can be pushed against the bank during high flows but not so long as to allow the kicker to be swept up onto the upper bank.

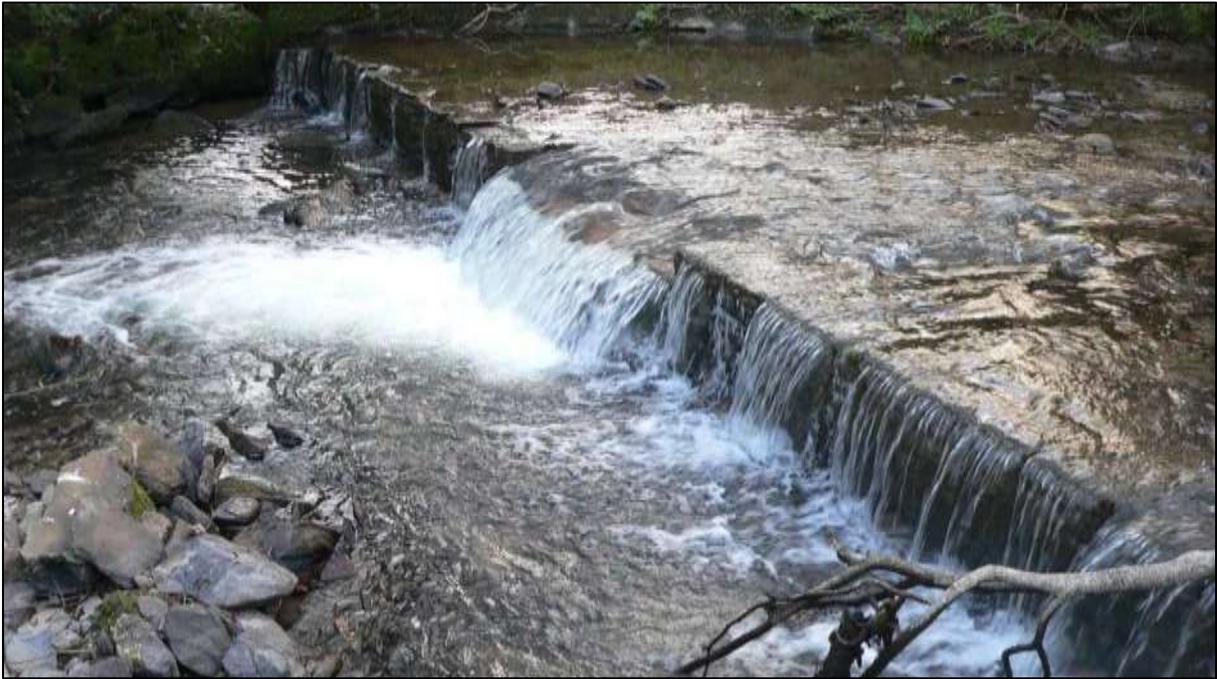
The River Haddeo is cut-off from its headwaters by the reservoir dam at Wimbleball Lake. Connectivity with one of the rivers major tributaries, the River Pulham is also hindered by a weir near its confluence with the Haddeo. Although not visited during the walkover, A photograph of the weir (Figure 12) suggests that the weir is a significant obstacle to fish passage and an impediment to substrate transport. Trout have been observed passing upstream via a notch in the weir (pers. comm. DAA) but the structure is likely to be a complete barrier to small fish under most flow conditions and even large fish during periods of lower flow.

Figure 12: The weir on the River Pulham is a significant barrier to fish passage

3. Work with Westcountry Rivers Trust and the owner of the weir on the River Pulham to explore options to improve fish passage. Ideally, the weir

should be removed to optimise fish passage and natural sediment transport. However, Should this option prove unfeasible at present, a low cost fish passage easement could improve habitat connectivity in the short-medium term.

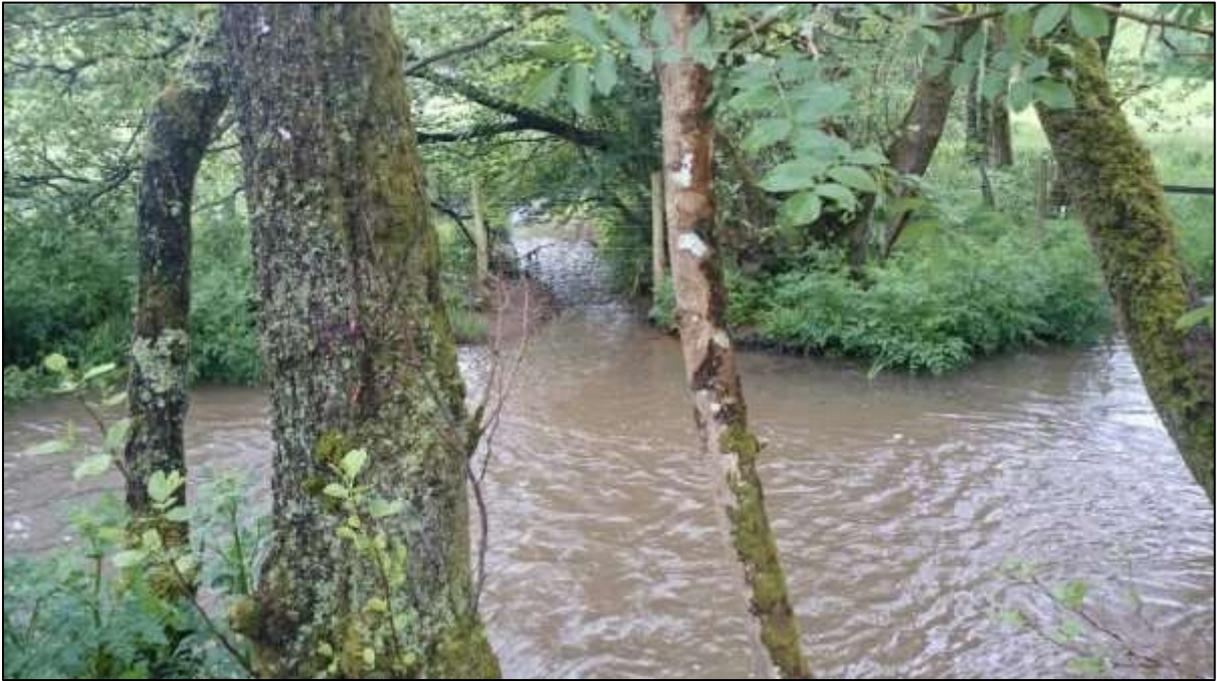
At the upstream extent of the Haddeo beat, a small tributary enters the river on the LB. This small tributary could be an important spawning stream and refuge during high flows. The stream was not investigated on the day of the visit and so further assessment may be required to characterise its potential. Ensuring that good quality spawning habitat is present in these small streams could be an important factor in protecting and possibly even boosting trout recruitment on the river. Trout sometimes preferentially select small side streams and tributaries for spawning, often resulting in increased juvenile survival as these small, protected sites offer a good protection from predation pressures from fish-eating birds and larger fish.

Figure 13: A small tributary could be a potential spawning stream

2. Investigate the small tributary shown in Figure 13 and any other small tributaries for their suitability as spawning streams for resident brown trout and sea trout. If required, carry out gravel cleaning works on locations within the small streams and the main river at locations likely to be used for spawning.

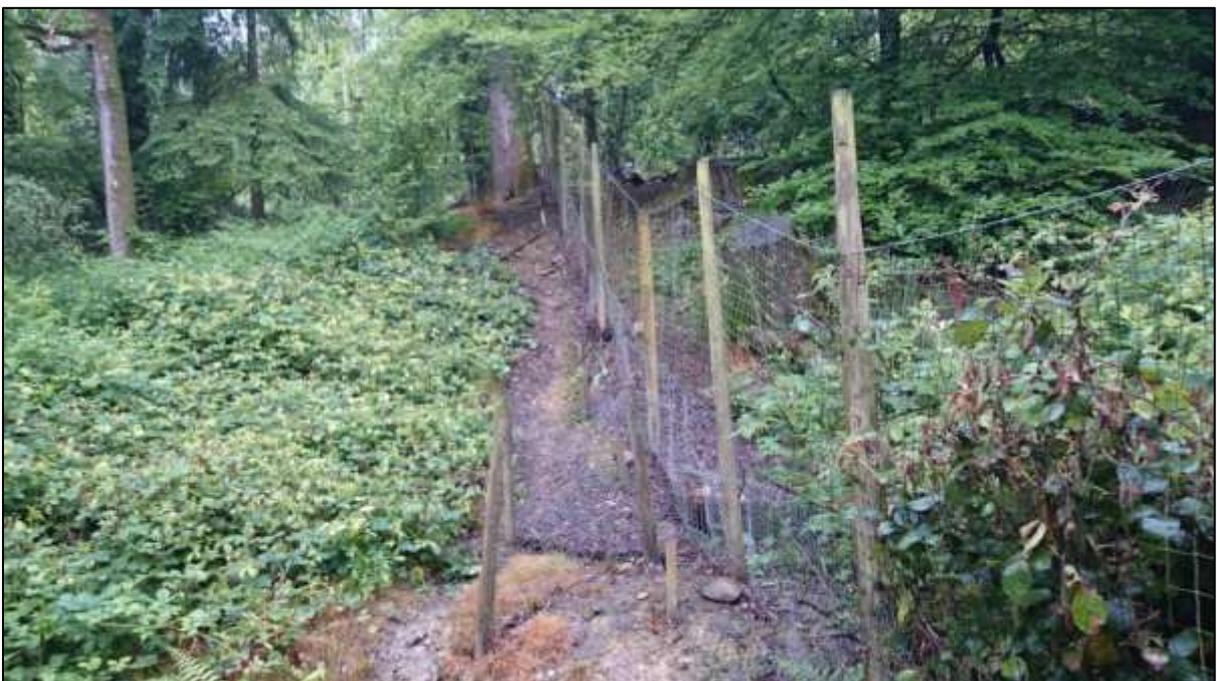
Throughout the Haddeo beat the landscape is dominated by large pheasant rearing pens. These are managed for the large Haddeo shoot. Unfortunately the intensity of the pheasant rearing operation appears to be having a negative impact on the river. In some places the pen fence line runs downhill towards the river. The cleared ground soil around the base of the fence line acts as a runnel for fine sediment (soil) to enter the river.

Figure 14: Cleared ground around the base of pheasant pen fences leave the soil exposed. Where the fences run down the valley side, soil is washed directly into the river

1. Engage with the land owners and management of the Haddeo shoot to explore options to minimise the risk of excess fine sediment and nutrients entering the river from in and around the pheasant pens. Diverting

drainage flow into some purpose-built settlement lagoons near the outfalls of the pen drainage ditches could be a cost-effective solution. The outfall from these lagoons could be bunded with heather (or similar) bundles to filter drainage water before it enters the river. Routing drainage water through some well-vegetated wetland scrapes (shallow ponds) may have a similar effect.

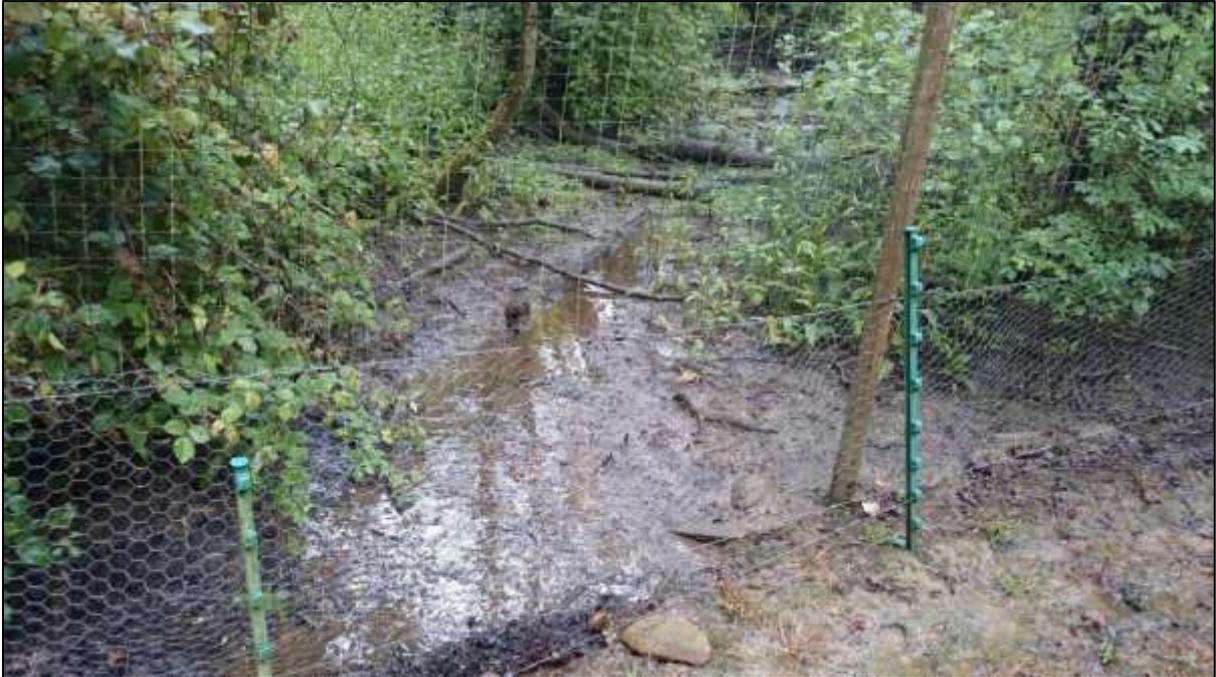
In addition, a number of drainage ditches flow out from the pens and discharge directly into the river. These ditches are point sources of fine sediment and potentially point source inputs of excess nitrate and phosphate. Further investigation into the water quality impacts of these ditches may be required.

Figure 15: A drainage ditch runs directly out from a pheasant pen and into the river

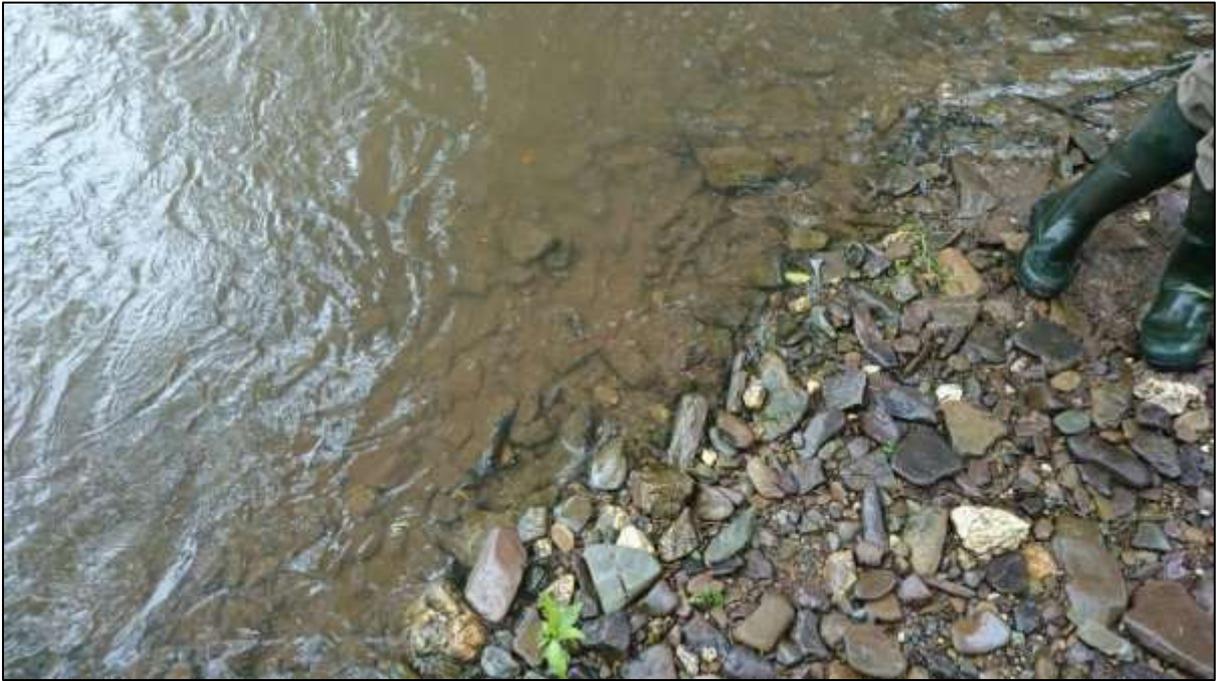
As flow in the Haddeo is largely reliant on controlled discharges from Wimbleball Lake, it is possible that the river's natural ability to flush fine particles downstream may be compromised by the artificial flow regime. The volume of fine sediment that any river can carry before habitat is degraded is difficult to quantify. However, a thin coating of silt could be easily seen coating the gravel bed in several locations suggesting that the river may be suffering from an overabundance of fine sediment.

Figure 16: A fine layer of silt can be clearly seen coating the gravel in the river margins

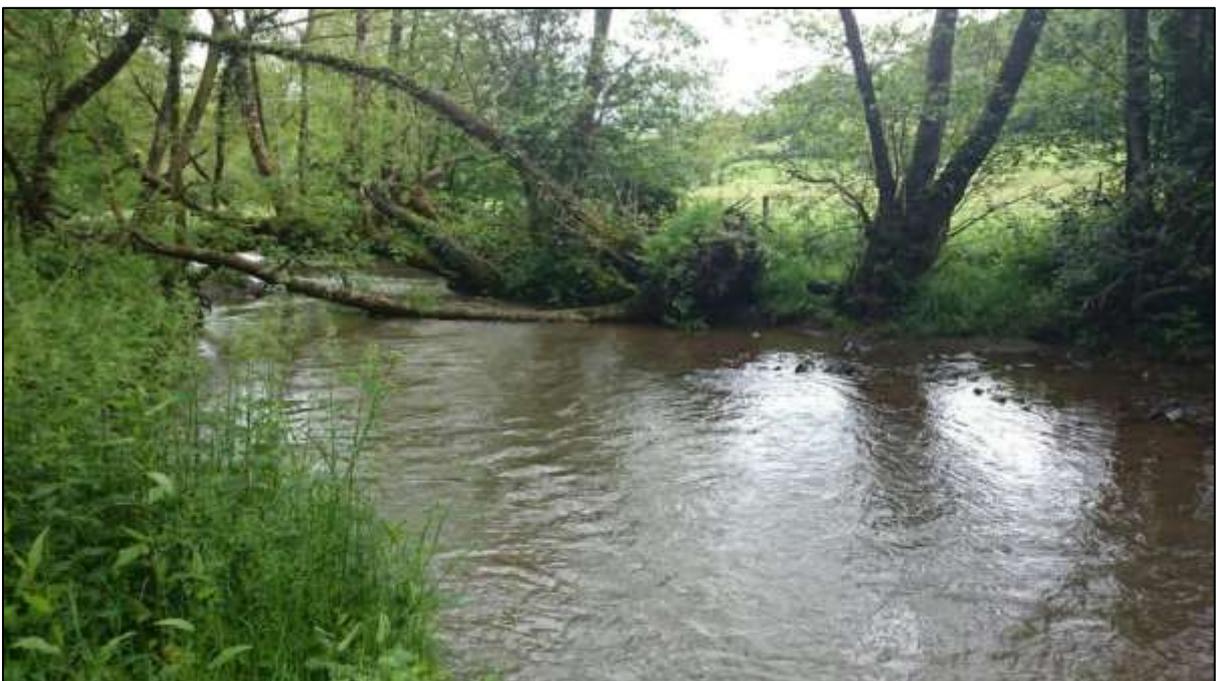
Natural Large Woody Debris (LWD) habitat was abundant and this was adding further complexity to the shape of the bed and the diversity of flow patterns (Figure 17).

Figure 17: Natural LWD features help to further diversify the river habitat

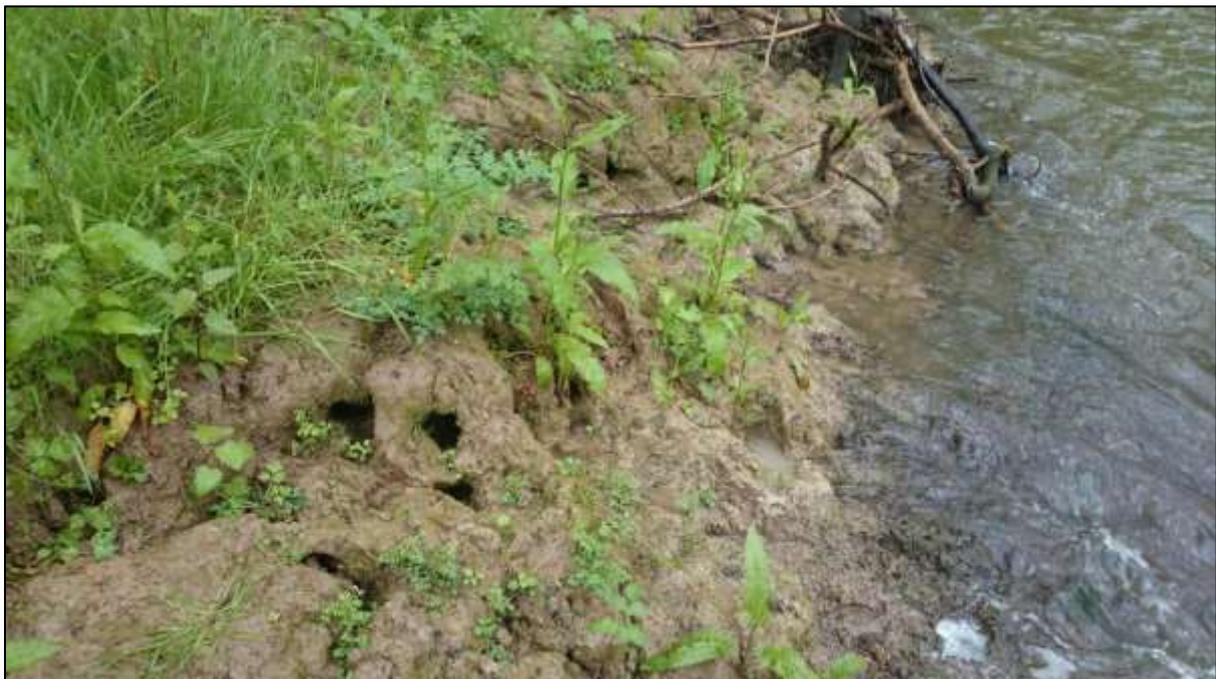
At SS 94092 26968 a dense series of burrows were noted within a muddy berm. No obvious signs of water voles were observed and from the squat shape of the burrows and the fact that the berm had probably spent much of the winter submerged, it is likely that they indicate an infestation of invasive signal crayfish (*Pacifasticus leniusculus*). Signal crayfish can cause a variety of problems in rivers. Apart from the devastating effect on native crayfish populations through competition and the transmission of crayfish plague (a disease to which native white-clawed crayfish *Austropotamobius pallipes* are thought to have no resistance), signals can cause extensive damage to the wider river ecosystem. Known to burrow up to 1.2m into banks, signal crayfish can cause erosion problems and accelerate rates of fine sediment input. They also eat the eggs of gravel-spawning fish as well as small fish such as bullhead or trout fry. In addition, crayfish compete directly with fish for food such as smaller freshwater invertebrates and can seriously impact densities of slow moving invertebrates such as caddis.

Figure 18: Burrows in the berm at SS 94092 26968 could indicate a signal crayfish infestation

Ascertaining the species responsible for the burrows, and if signal crayfish are present, ascertaining the extent of the infestation, could be important for the health of the fishery and the Haddeo ecosystem as a whole.

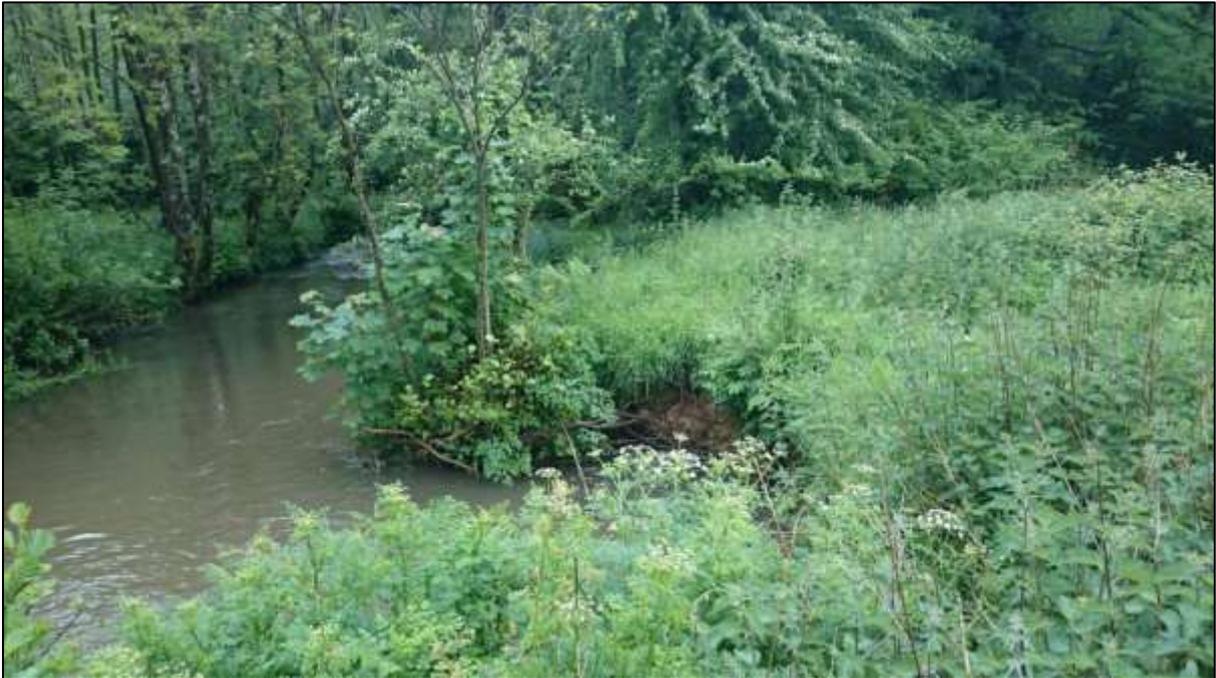
A short distance downstream a small eroded bay has formed. Whilst the erosion is not necessarily a significant problem for the river, it could pose a health and safety or access problem for anglers. Patching up the erosion with a sloping brushwood revetment using material won from a nearby tree would be a relatively simple solution.

Figure 19: A small eroded bay could be patched with a brushwood revetment if required

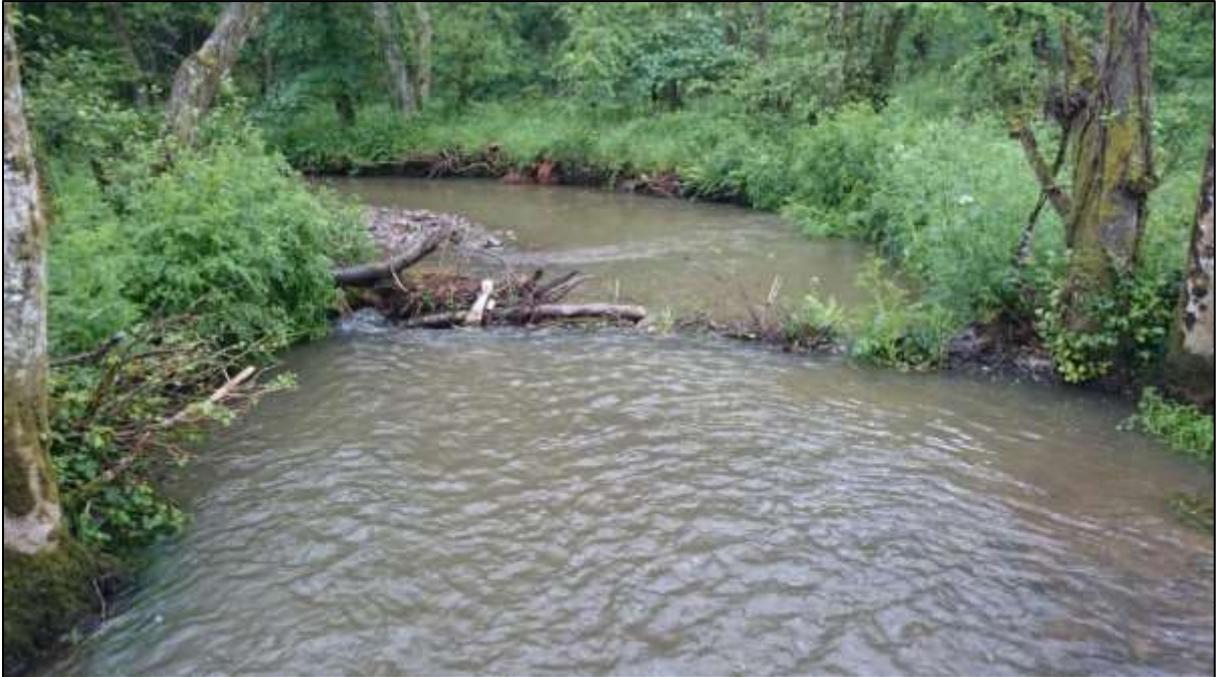
However, debris dams can sometimes impound flow and even become barriers to fish passage. It is important to assess these structures on an individual basis and where necessary, partially dismantle them so that they do not cause excessive sedimentation or obstruct salmonid migration.

Figure 20: The natural debris dam observed during the visit. Whilst important for the river food chain, debris dams should be individually assessed for fish passage and their impact on upstream habitat.

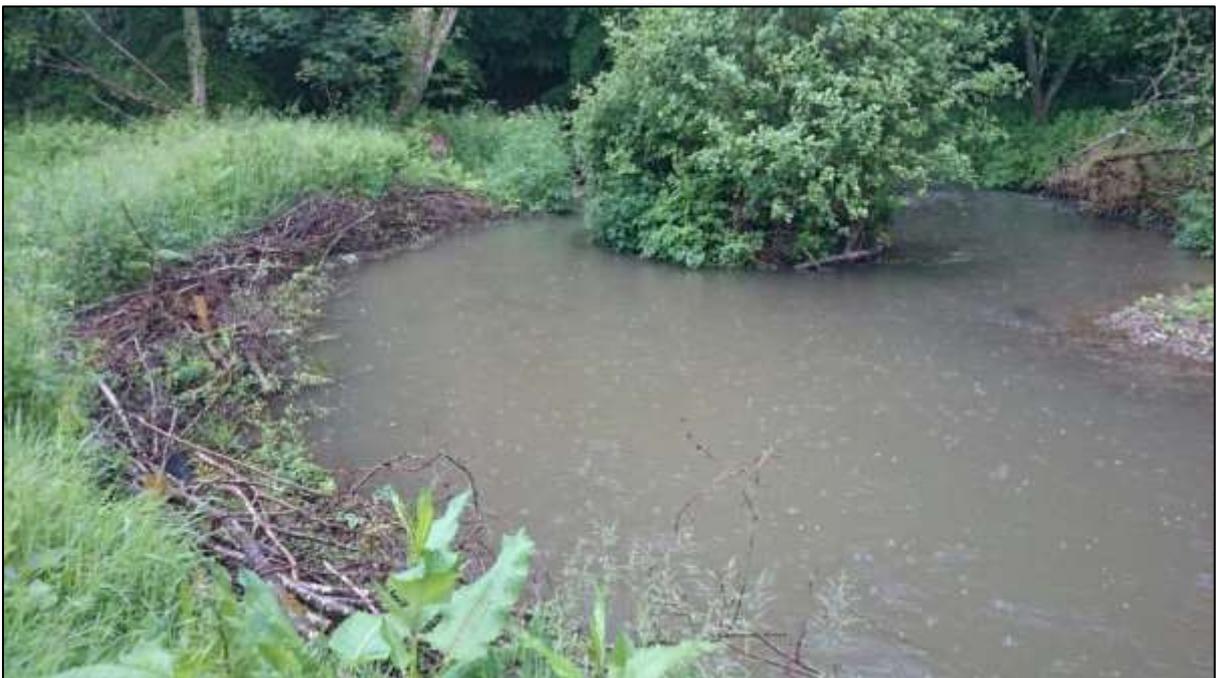
Examples of the DAA's previous erosion control/habitat enhancement brushwood structures (Figure 21) indicate that the association is sufficiently experienced to undertake such works.

Figure 21: At the downstream extent of the Haddeo beat is another good example of the club's marginal habitat works.

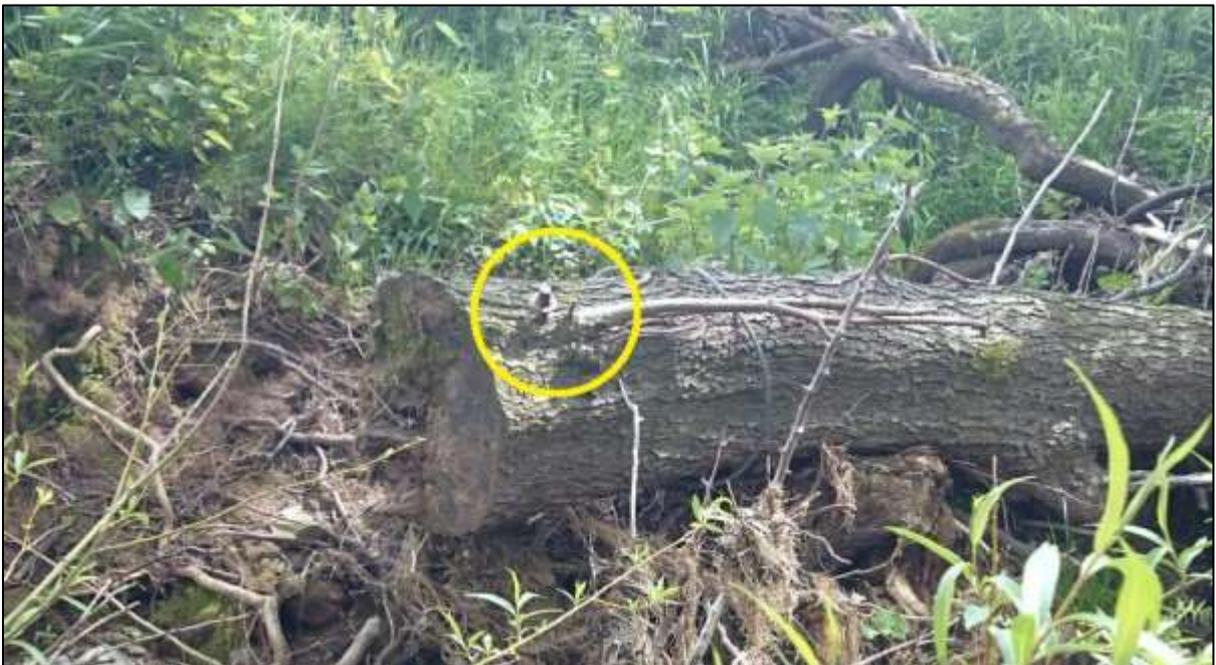
Figure 23: An example of rebar driven through a pre-drilled hole to secure LWD to the bank. One at each end of the trunk should suffice if the tree is hinged (still attached to its trunk)

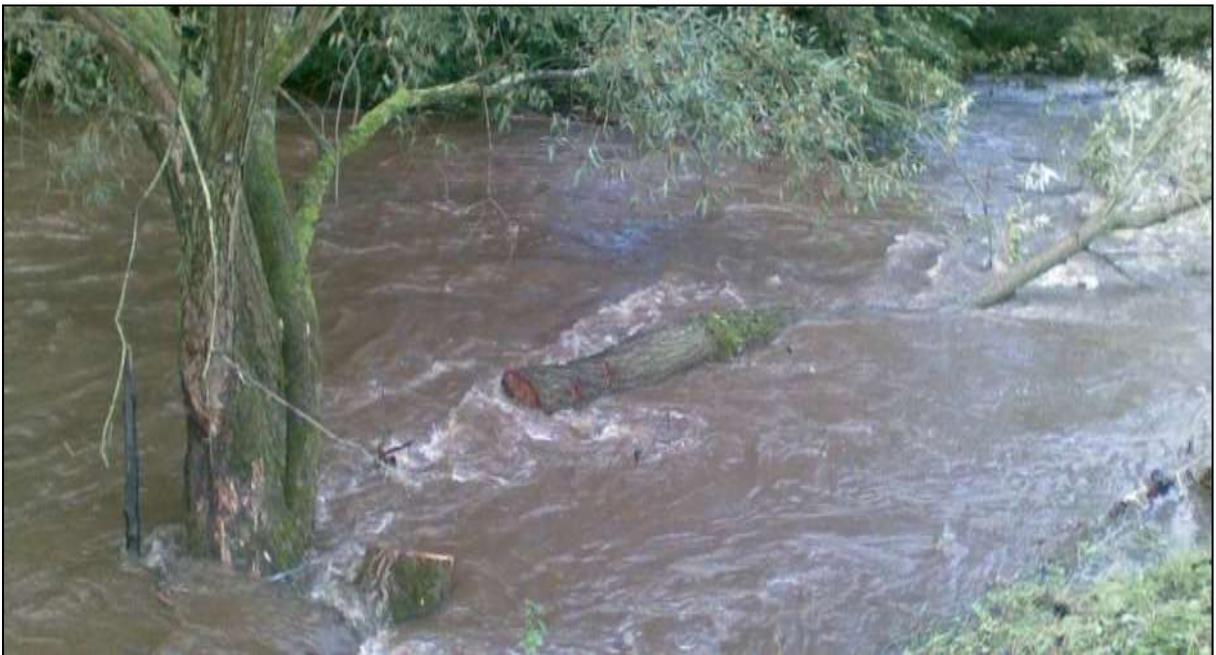
The kicker will provide valuable cover for fish and food/habitat for freshwater invertebrates without increasing flood risk. During high flows the kicker will be swept against the bank and out of the strongest current. The cable also allows the wood to rise and fall with changing water levels

Figure 25: An example of a marginal kicker during high flows
